# HELENA RESTAURI

PORTFOLIO  
2021

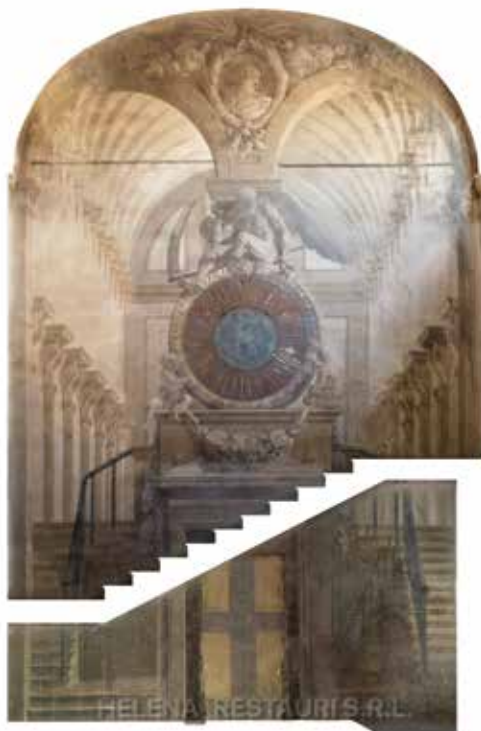
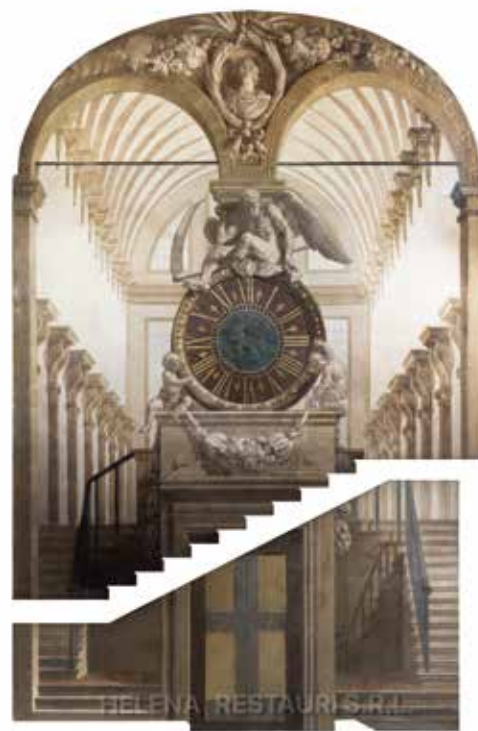
At the beginning of the restoration work, the work was covered by surface deposits, stains due to the presence of humidity and pulverization of the color in different points. After the dry cleaning operations, we proceeded with the consolidation of the pictorial film and the reintegration of the watercolor paint.

Before

After

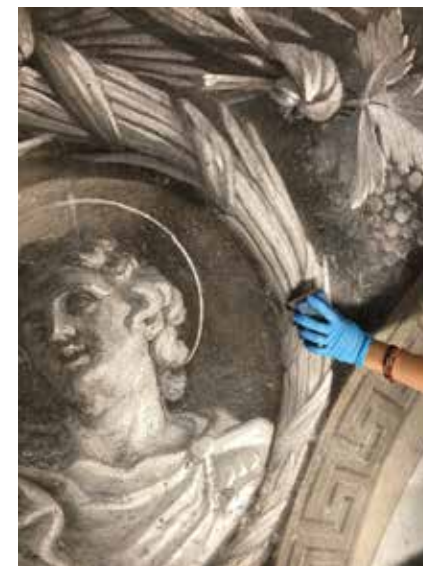
FRESCO'S DETAIL DURING  
THE RESTORATION WORK

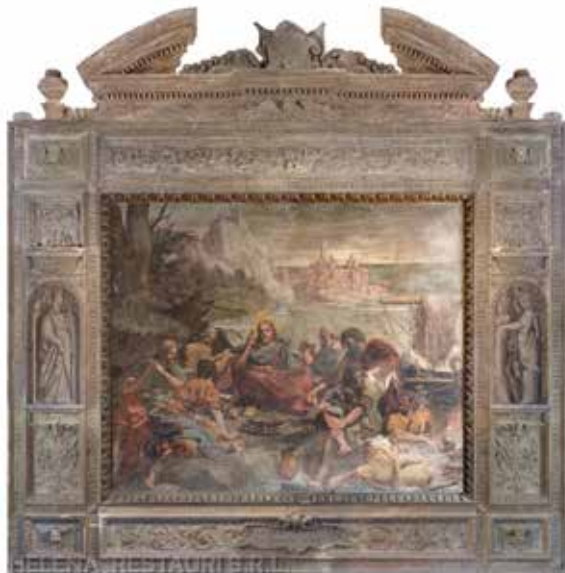
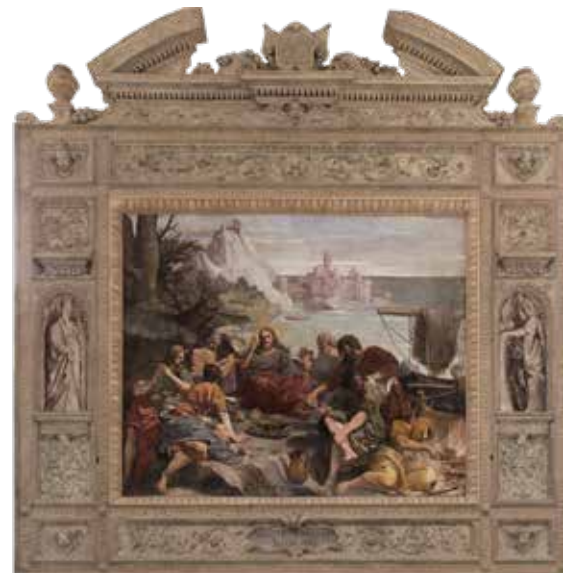
The construction of the building, actually the Bologna's courthouse, began in the 11th century but it was around 1550 that it reached its current configuration. Starting from the end of the nineteenth century, the building lost its religious function and changed many uses, this led to major changes from an aesthetic point of view, until it was completely abandoned in the mid-twentieth century. When the restoration began in 2019, the fresco and the frame made by Lionello Spada were in a poor state of preservation: there were dust, bird droppings and various stains on the entire surface. The plaster frame had been covered with several layers of plaster and varnish which were now altered; the colors of the fresco were altered and there was the presence of salts in some parts of the work. After the preliminary investigations, it was decided to alternate comic cleaning with laser cleaning to obtain the best possible result and to reduce the environmental impact of the work and to obtain the best possible result. After cleaning, the surfaces were retouched with watercolor paints.

Before

After

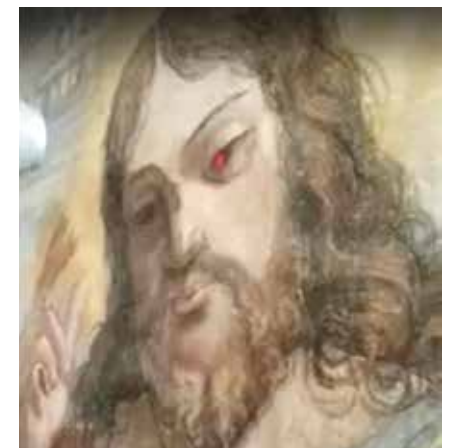
Detail of restoration using Laser eos.

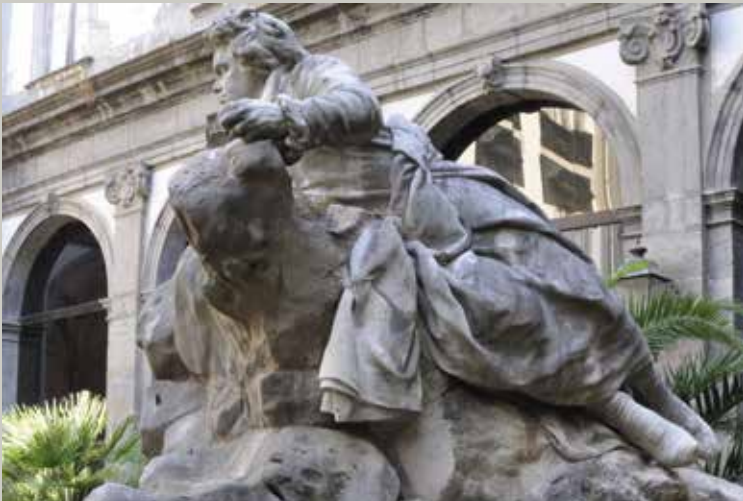
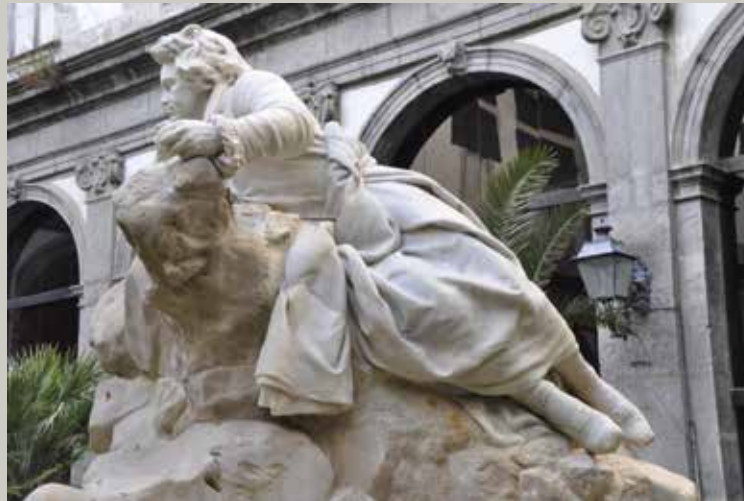
Given the location of the sculpture in a green area, the most evident and extensive forms of degradation were of a biological nature and for this reason it was decided in collaboration with the ENEA research center to use a product of origin within the restoration mortars. plant that could slow down the proliferation of biodeteriogens: NopalCap.

Before

After

This product consists of the mucilage of the prickly pear and the extract of chilli peppers of the capsicum genus and is inspired by ancient techniques used by Mexican populations in the creation of mortars for wall paintings.

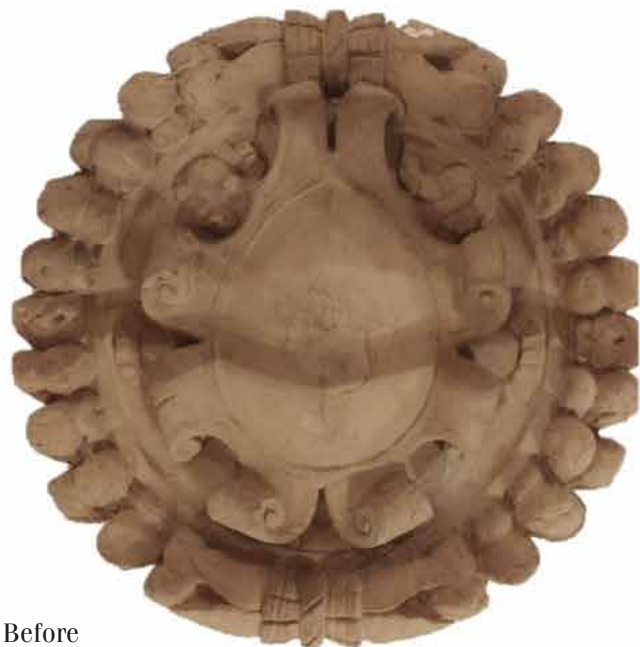
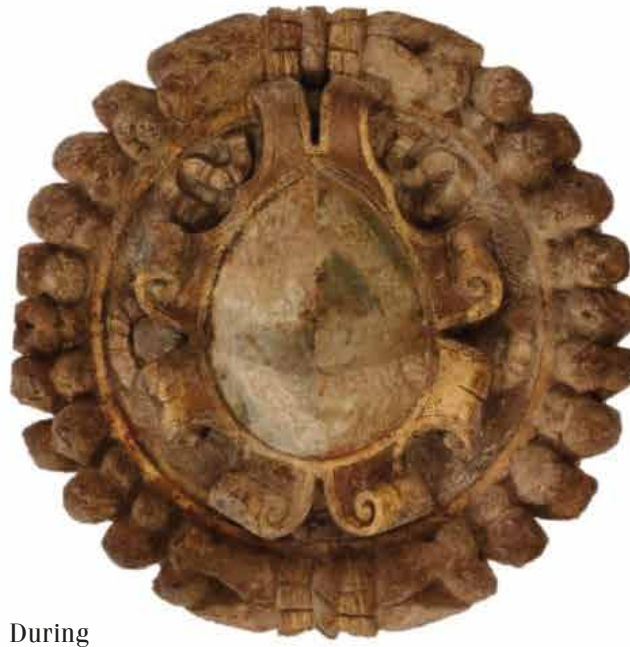
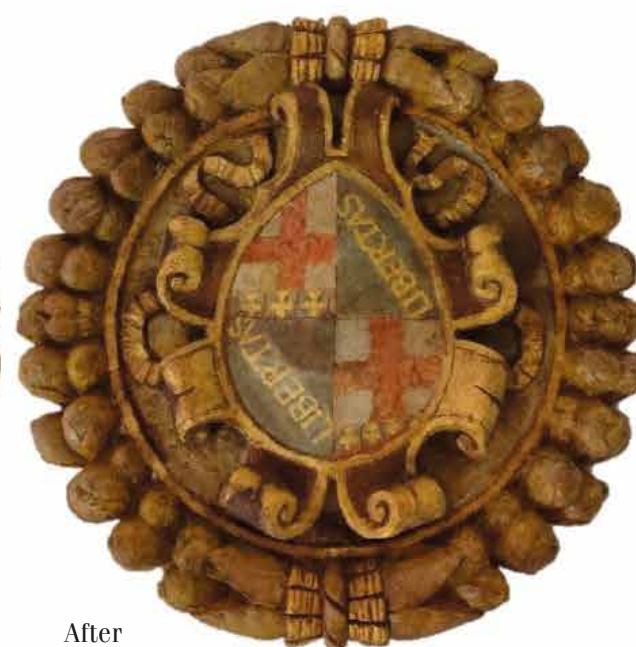
Before

During

After

Before the restoration, the work was covered with several layers of plaster that prevented the reading of the model and the original colors. After the removal of the layers it was possible to notice the presence of gold leaf and color residues in the central part of the coat of arms where the insignia of the city of Bologna were painted. The restoration operations ended with the watercolor painting retouching which restored legibility to the entire work.

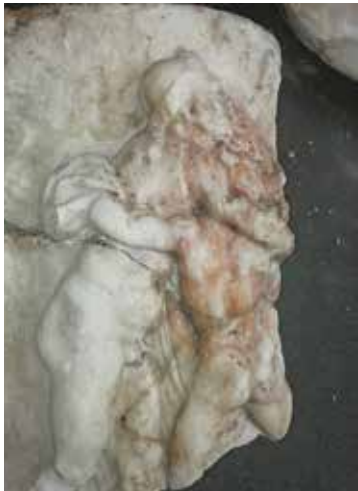
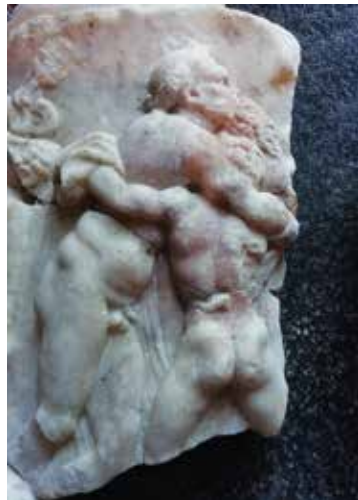
Before

After

The work, made of Pentelic marble and kept inside the Campano museum in Capua, represents an important testimony of the Greek civilization in Campania. Before the restoration on the surface of the fragments, many earthy encrustations from excavation were still visible and some of them had been glued incorrectly with materials incompatible with the original stone; the restoration therefore included the cleaning of all the fragments, the removal of the glues used in the previous intervention and the correct gluing of the fragments.

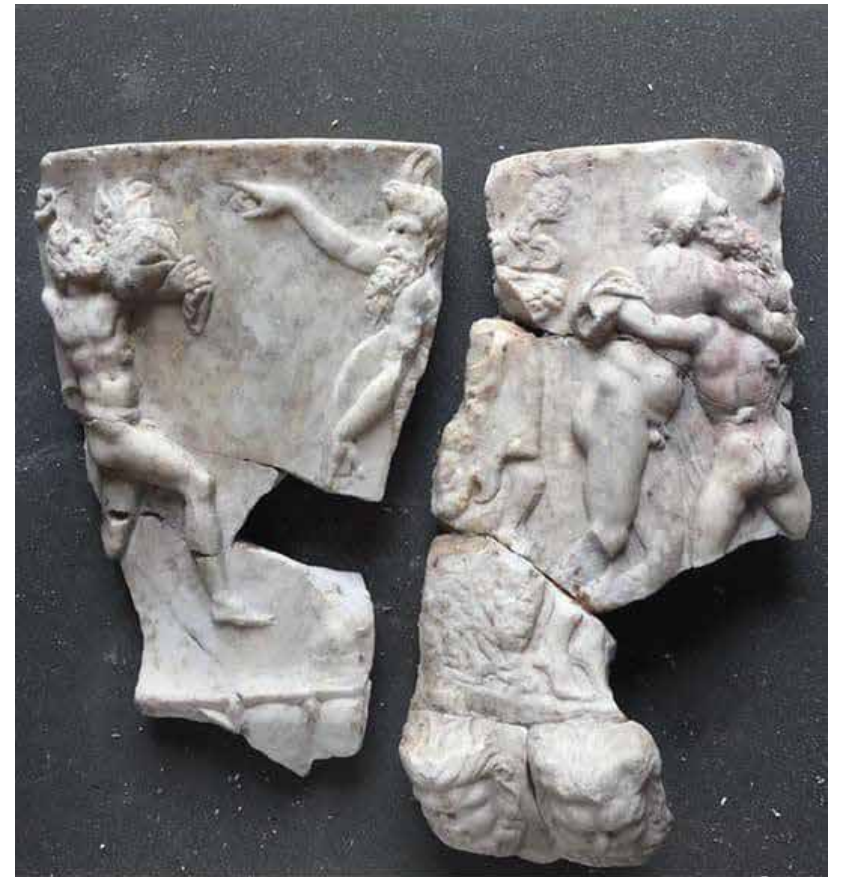
PORTION OF CRATER AFTER RESTORATION

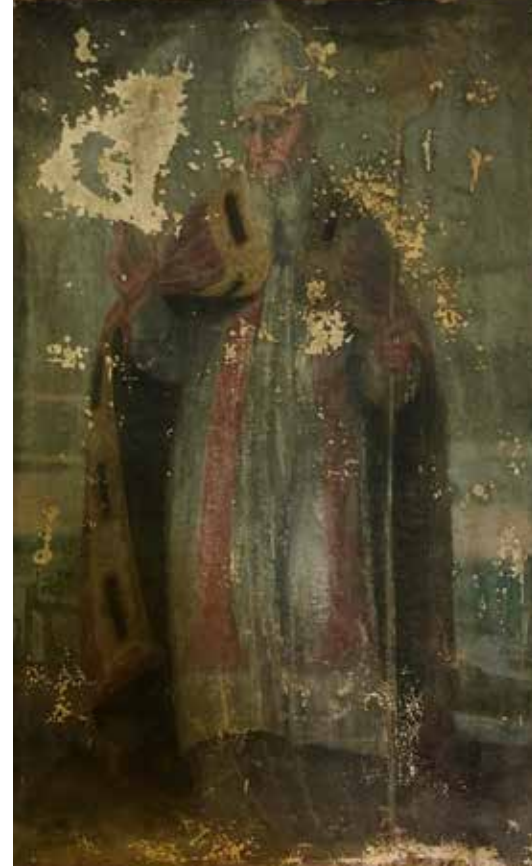
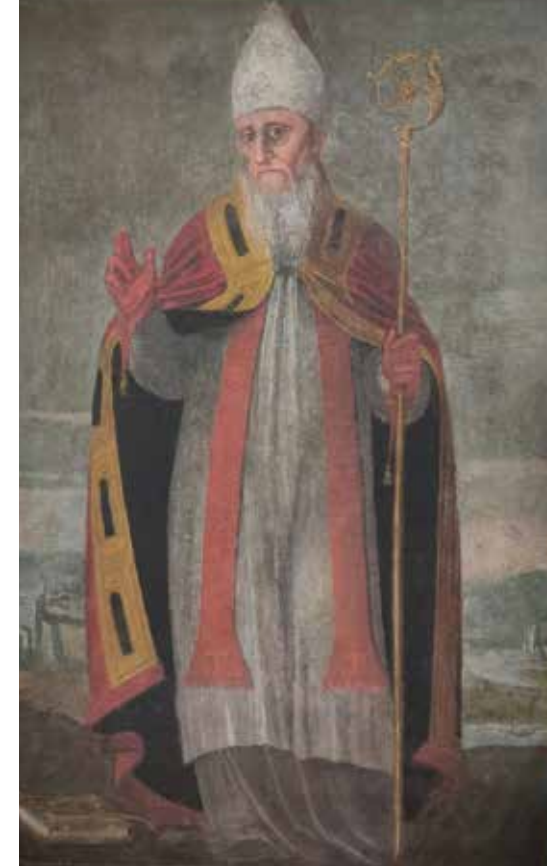
Before

After

Before the restoration, the work was in a bad state of conservation, the most evident forms of degradation were due to water infiltration caused by incorrect conservation of the work in a humid environment. After retensioning the canvas, the pictorial film was consolidated and integrated with plaster and watercolor retouching.

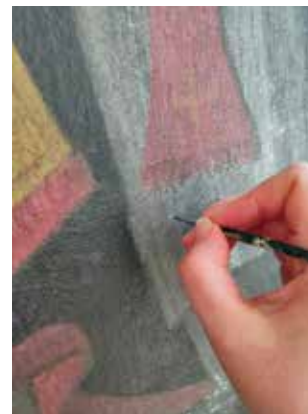
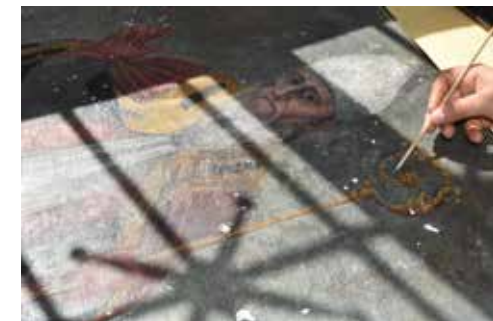
DETAILS PAINTED ON CANVAS  
DURING THE RESTORATION WORK

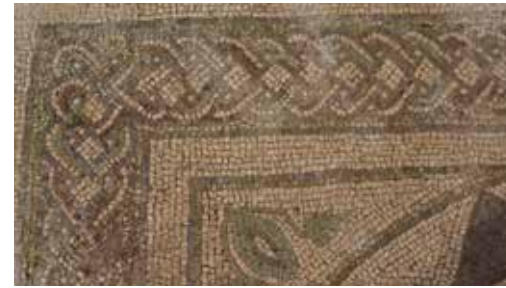
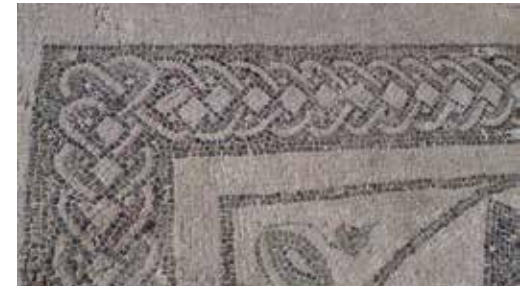
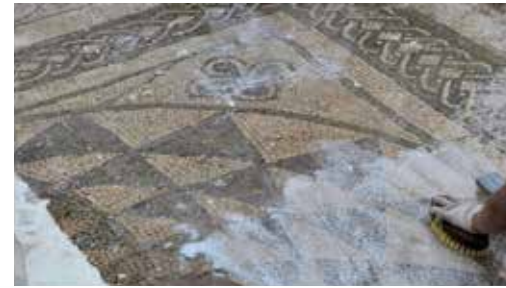
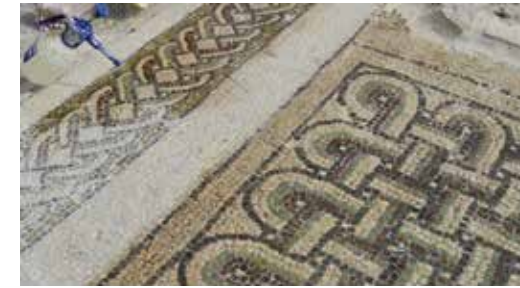
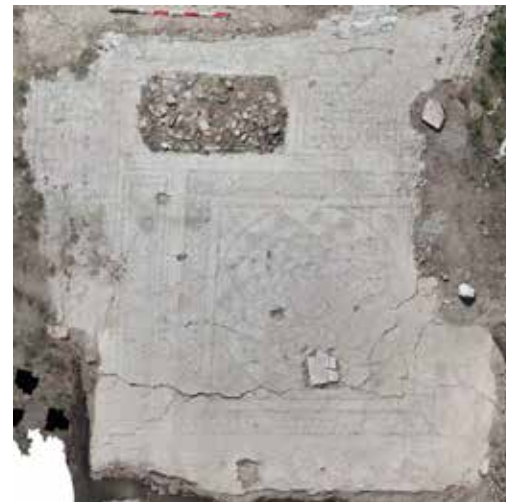
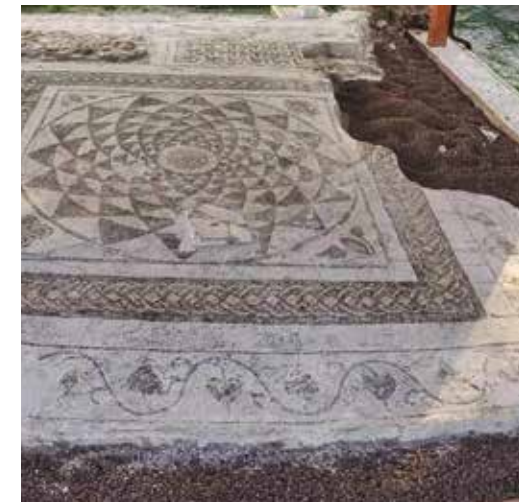
At the beginning of the restoration operations the work was covered by dust and soil, the interstitial mortar was almost completely absent and there was the presence of roots in various points, in addition the layers below the mosaic carpet which generally constitute the support to the ground, they were completely absent making the whole structure unstable.

The restoration operations involved first of all the consolidation of the underlying earth through the insertion of pins and injections of hydraulic lime, secondly we proceeded to the cleaning of the tiles and the compensation of the interstices with hydraulic mortar.

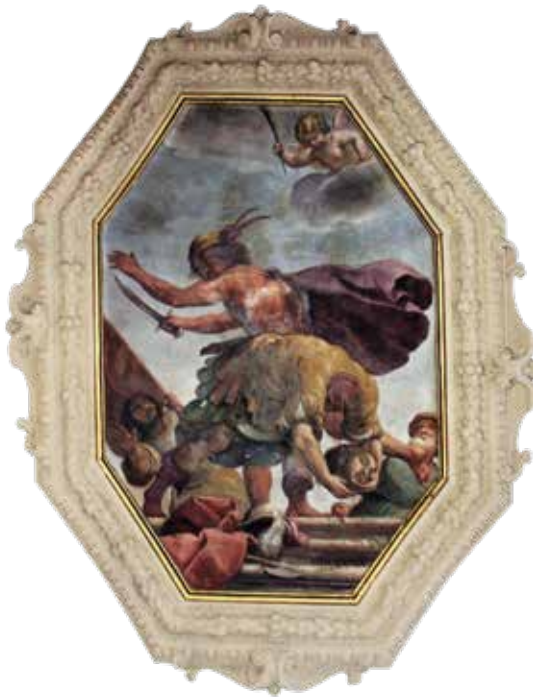
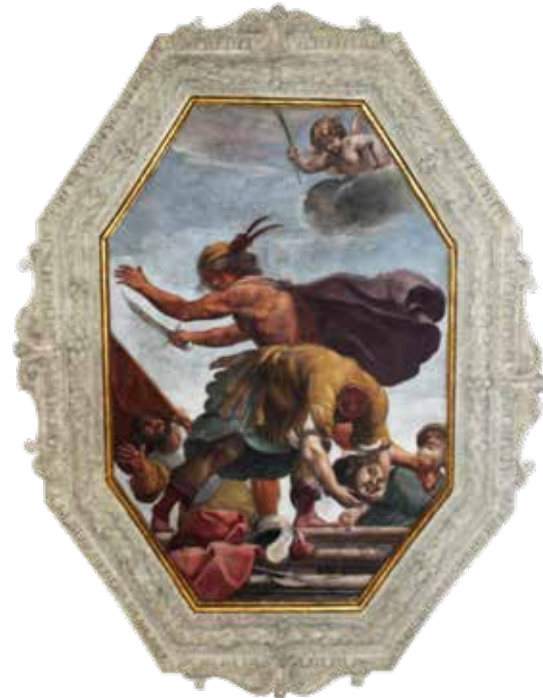
Before the restoration, the work was in a fairly good state of preservation, there were obvious stains due to water infiltrations and various gaps in the pictorial film located in different points of the surface.

Before

After

The restoration involved not only the surface of the fresco but also the gilded wooden frame and the painted stucco frame.

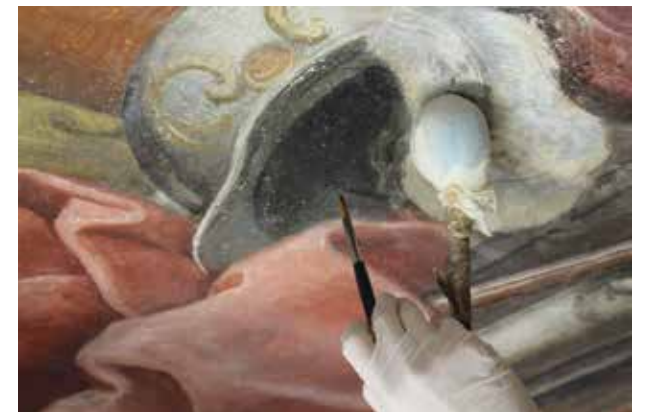
DETAILS PAINTED ON CANVAS  
DURING THE RESTORATION WORK

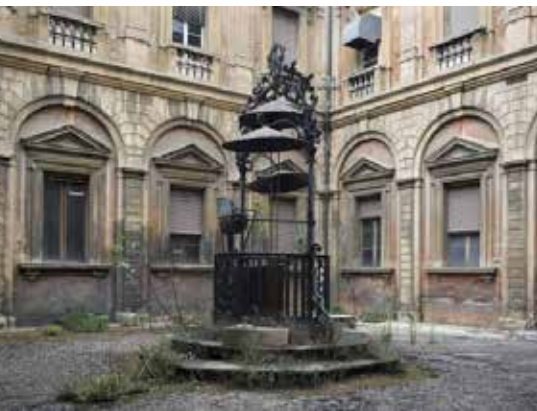
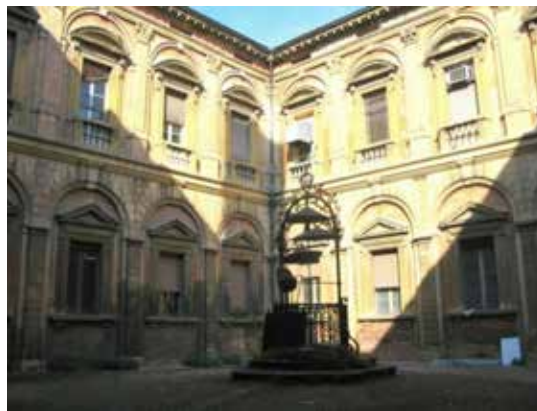
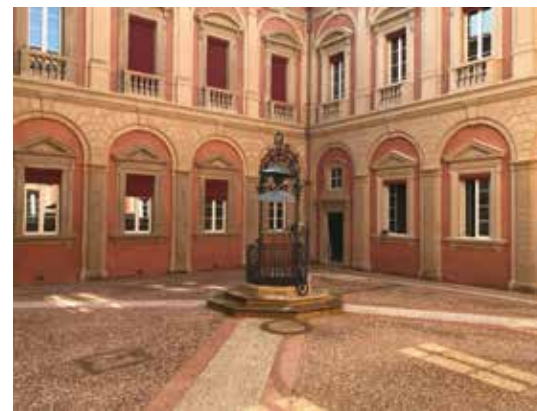
When the restoration work began, the plaster on the facades was incomplete in many ways, the sandstone of the remaining original windows was completely decay and many of the bosses were completely absent. The well located in the center of the cloister was also in a bad state of conservation, showing evident oxidation and the growth of plants.

Before

After

The restoration work involved a biocide treatment extended to all surfaces, a consolidation of all the sandstone elements, the grouting and remaking of some decorative elements with hydraulic mortar and the chromatic harmony of all the elements through lime colour.
